Manhole Inspection Summary

Manhole # S51S1_004MH

Location Address: **3101 Frankfurst Ave.**

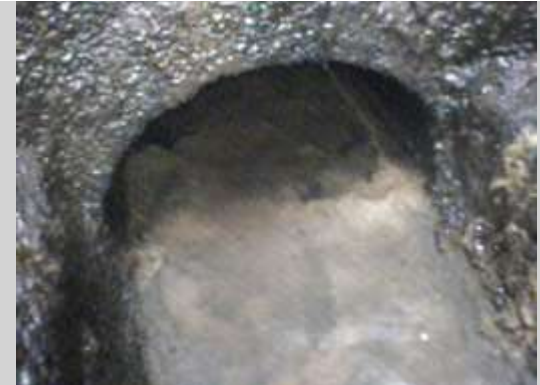
12 O'Clock Outflow

Pipe Height: **14.4** (in.) Rod and Bar (Angled)
Pipe Material: **Clay** ☐ Pipe Lined
Invert Depth: **10.44** (ft.) Flow Characteristics: **Fast**
Deposits: ☒ None ☐ Mud ☐ Sludge ☐ **Debris** ☐ Grease
Silt Depth: (in.) Deposits Extent:
Infiltration: **None** Pipe Seal Cond: **Sound**

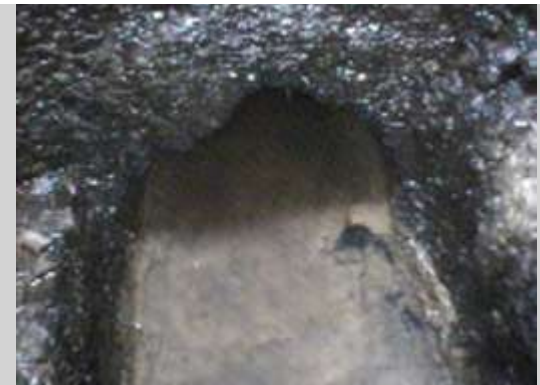
6 O'Clock Inflow

Pipe Height: **14.4** (in.) Rod and Bar (Angled)
Pipe Material: **Clay** ☐ Pipe Lined
Invert Depth: **10.40** (ft.) Flow Characteristics: **Fast**
Deposits: ☒ None ☐ Mud ☐ Sludge ☐ **Debris** ☐ Grease
Silt Depth: (in.) Deposits Extent:
Infiltration: **None** Pipe Seal Cond: **Unknown**
